Forest Service Manti-La Sal National Forest Ferron/Price Ranger District Ferron Work Center 115 West Canyon Road

I am sending you a compact disc (CD) with inspection reports and photographs from the Pines/Muddy area and Starpoint Springs on the Manti-La Sal National Forest. This is for the purpose of information-sharing between our agencies.

On Tuesday May 10 I went to the Emery allotment to check the condition of the range and Range improvements, the grass was just starting to "green up" brome was between 2 to 5 inches tall and the poa was only about an inch tall. The road was still damp but not muddy. The first improvement I inspected was 'Verdus Pond" It still had a small snowbank on its west side (see Picture #1) and a small puddle of water in the bottom but just east of center there is a large crack in the bottom (see Picture 2-6) and there is evidence of large amounts of water flowing into the crack instead of being stored in the pond. (see picture 7) Directly south of Verdus pond and across the road there was a puddle of water approximately 12 feet across and 4-6 inches deep.(see picture 8) This tells me that there would have been more water in the pond if it did not have

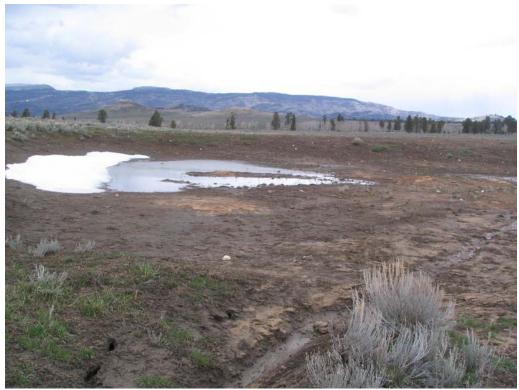
Picture # 1 taken 5\_10\_05 Snowbank and water in verdus pond

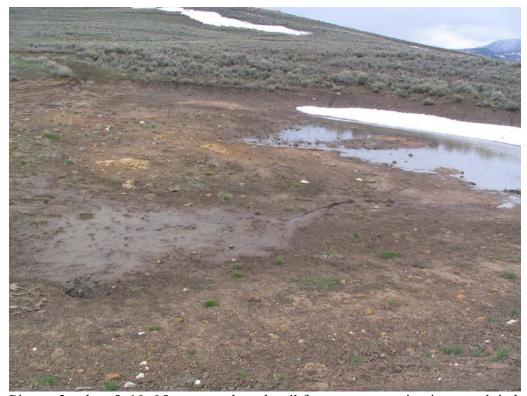
Picture 2 taken 5\_10\_05 water and mud trail from water running into crack in bottom of Verdus pond.

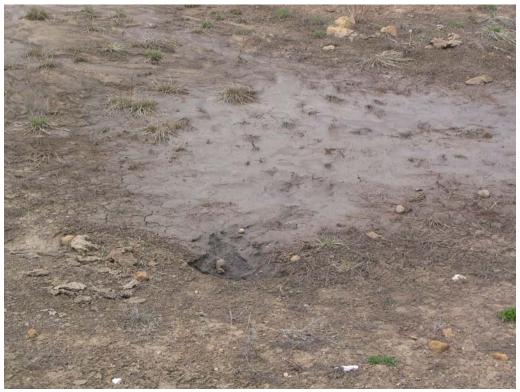
picture 3 taken 5\_10\_05 Crack in Verdus Pond

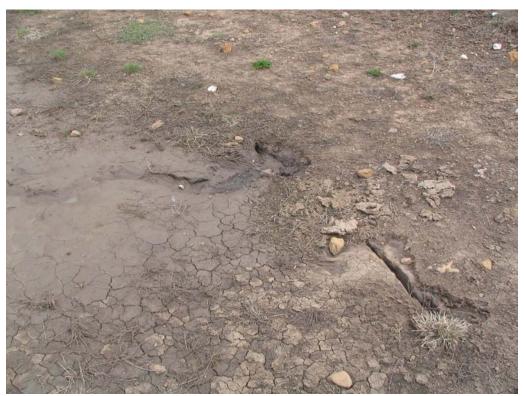
picture 4 taken 5\_10\_05 Crack in Verdus Pond

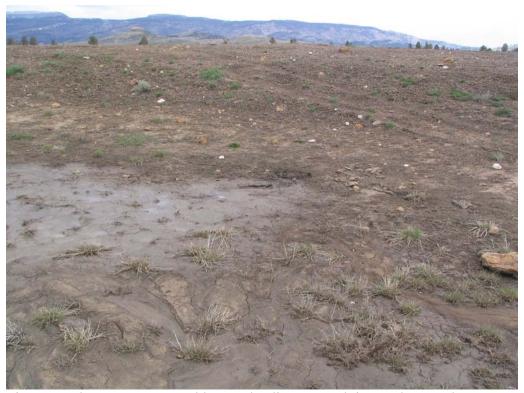
Picture 5 taken 5\_10\_05 muddy area leading to crack in Verdus Pond

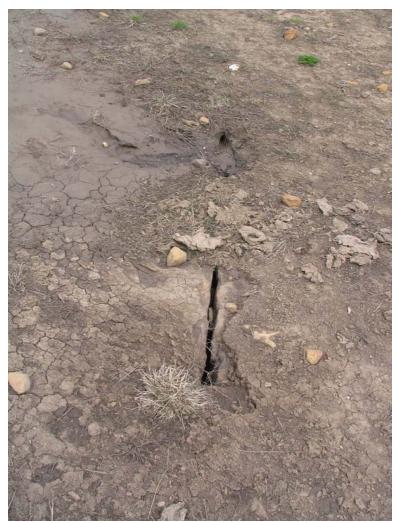
picture 6 taken 5\_10\_05 Crack in bottom of verdus pond

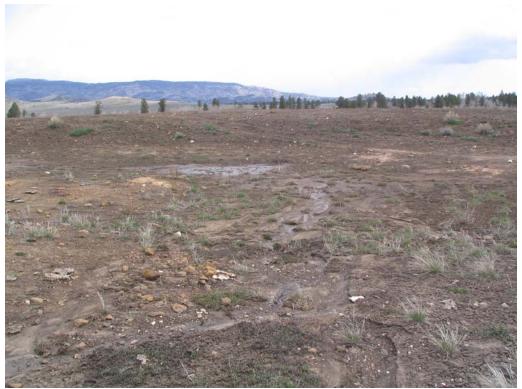
Picture 7 taken 5\_10\_05 evidence of high water amounts flowing into crack in Verdus Pond

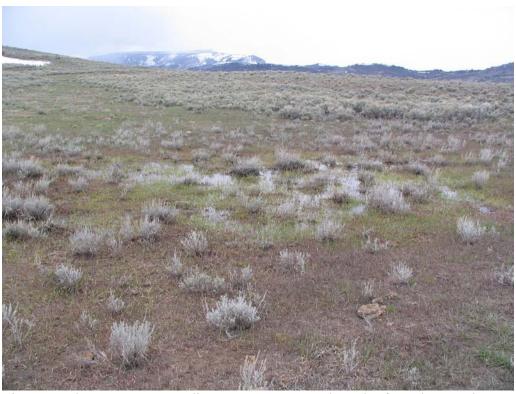
Picture 8 taken 5\_10\_05 standing water across road south of Verdus Pond

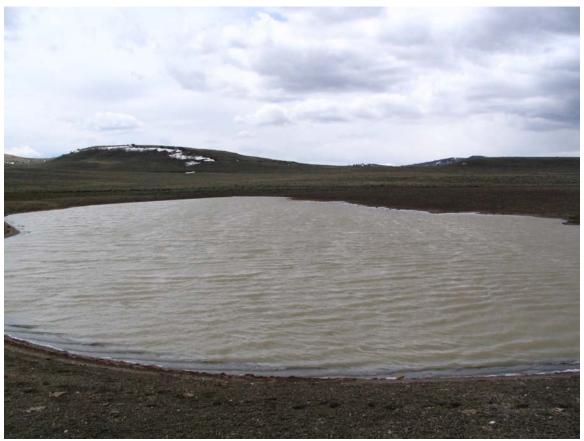
I then traveled to Box Pond and pleasantly surprised to find it near full (see picture 9) but upon closer inspection I found it had receeded about 3 feet this spring, (see picture 10) there are no cattle on the allotment at this time and little elk sign near the pond and with temps as low as they have been I see no reason why the water would be receeding unless there is a crack in the bottom.

Picture 9 taken 5\_10\_05 Box pond

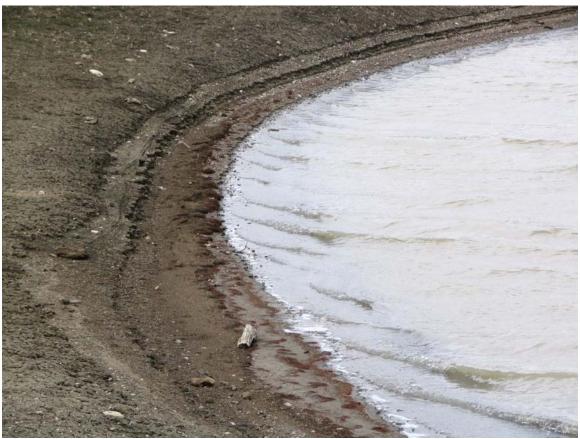
Picture 10 taken 5\_10\_05 High water mark showing that water level is receeding rapidly

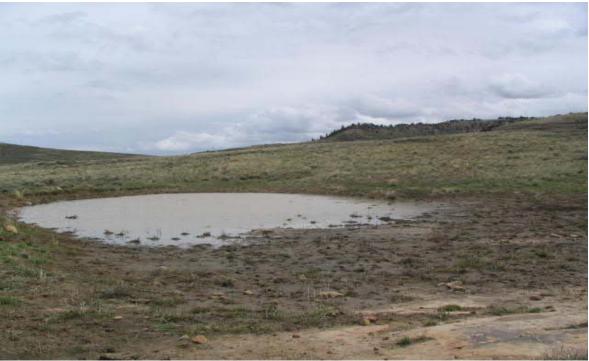
From Box Pond I traveled south/southeast to Johnson Pond. I have never seen water in this pond until now but I have never been there this early in the year. It is also receeding rapidly without any use from livestock. And there is no evidence of water flowing away from the pond. The Johnson Pond Dam is showing some major erosion on the back side but it was difficult to tell if it was from water or animals.(see Picture 11)

Picture 10 taken 5\_10\_05 Johnson Pond note large muddy area around outside edge of water. Water seems to be disappearing.

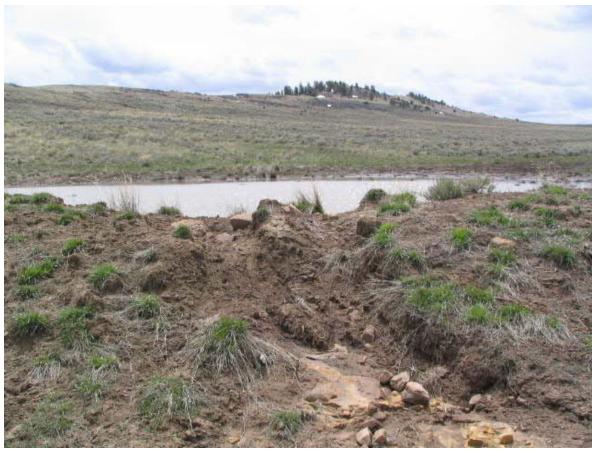
Picture 11 taken 5\_10\_05 erosion of back of Johnson pond dam

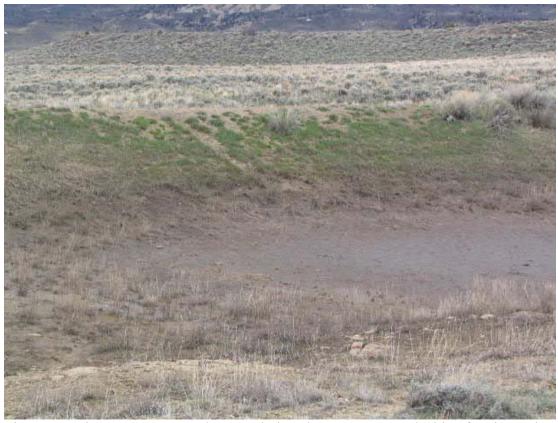
After leaving Johnson Pond I drove back to the main road and turned south then west to a pond that is located just north of the main road. It has a large dam and should have a lot of water in it but there was none. However the bottom was very muddy indicating that there had been water recently. (see picture 12) note the obvious high water mark in the grass on the banks of the pond

Picture 12 taken 5\_10\_05 Pond near quitchapah canyon on north side of main road. Empty, but bottom is muddy note high water mark about half-way up dam

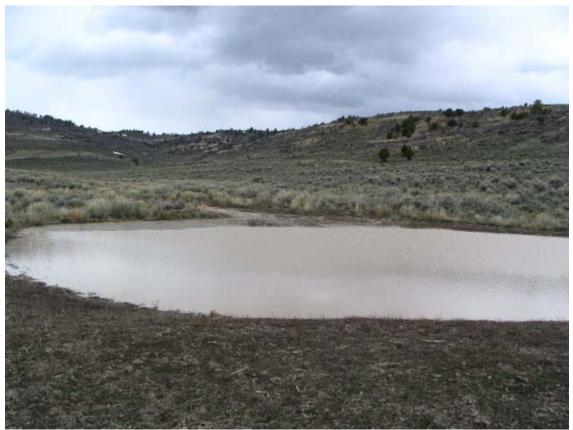
I also noted that the pond that is approx 1 mi. directly west of Box Pond is completely full (see picture 13) and there was a lot of standing water in the flats southwest of Box pond. (see picture 14)

Picture 13 taken 5\_10\_05 pond approximately 1 mi. west of Box Pond.

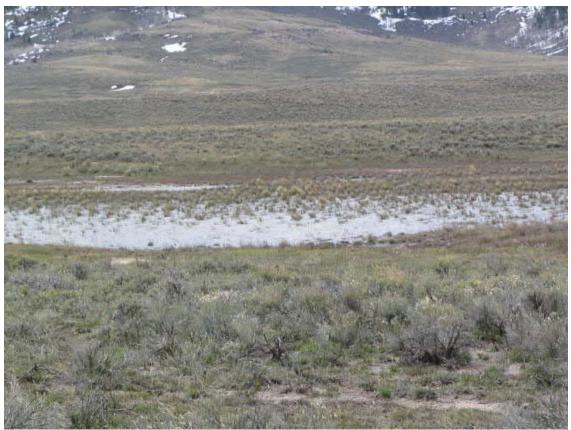
Picture 14 standing water in flat southwest of Box Pond

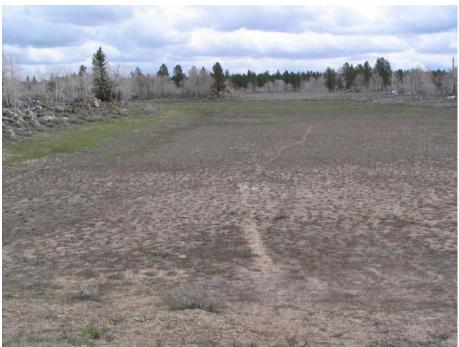
I then traveled back toward "The Pines" and stopped at Slab Pond it was very dry and there was little evidence that any water had even reached it. I walked around the edges of the pond and found several major cracks in the surface, perhaps they have stopped the water from reaching the pond. (see picture 15-17)

Picture 15 taken 5\_10\_05 slab pond dry!!

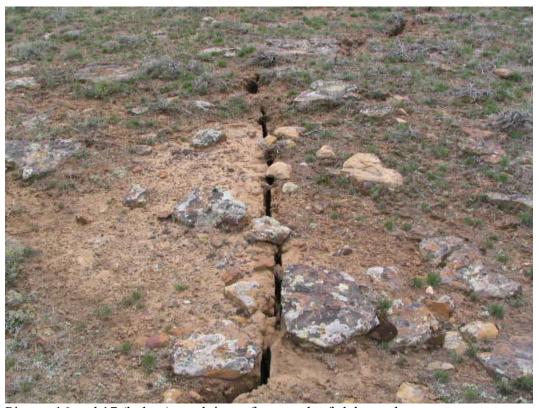
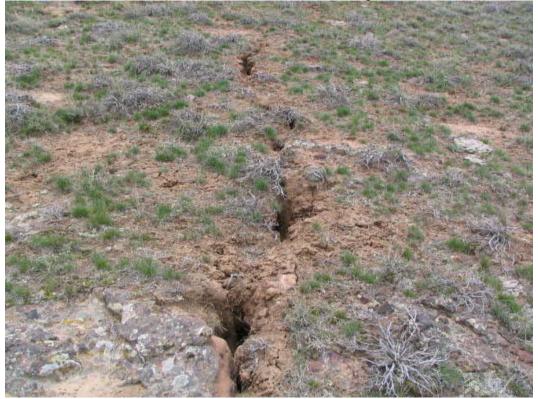
Picture 16 and 17 (below) crack in surface south of slab pond

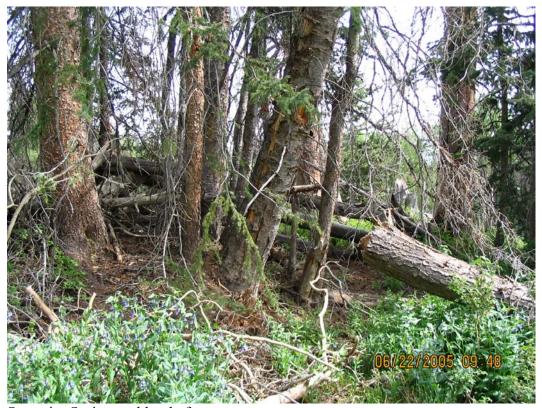
Starpoint Spring – old pole fence

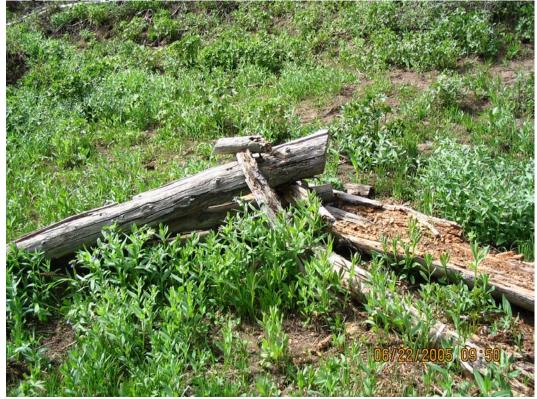
Starpoint Spring – fill slope above spring

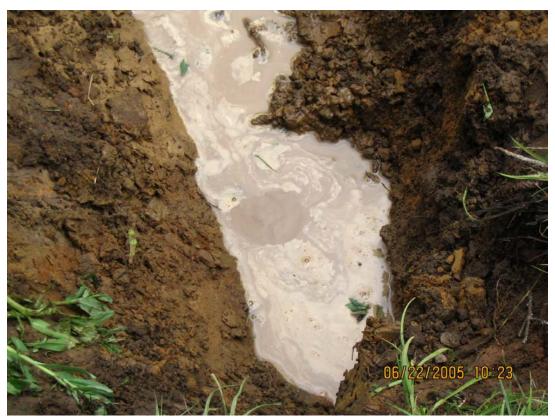
Starpoint Spring – water ponding in dug-out spring depression
